# Preliminary Site Investigation (Contamination) – Fonterra Edgecumbe WWTP

Prepared for Fonterra Co-operative Group Ltd Prepared by Beca Limited

8 July 2022

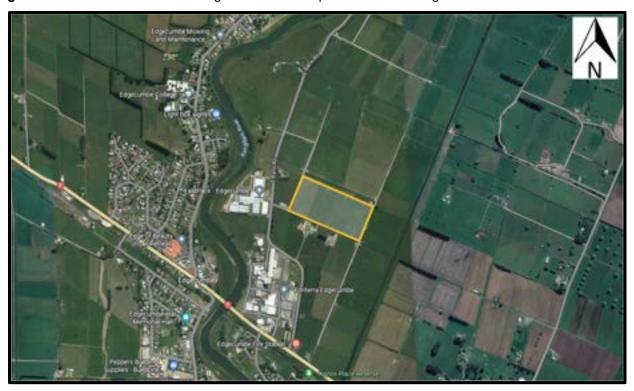
Figure 1a - The site (yellow) of this investigation. Source: Google Maps

The site of this investigation is outlined in **Figure 1a**, with **Figure 1b** depicting an overlay of the current proposed design layout of a WWTP. The site of this investigation includes both the lot outlined in 'yellow' (Fig. 1a) and the red line indicating associated pipe connections to the new facility (Fig. 1b). It is understood that Fonterra currently hold a 'site wide' NESCS consent for earthworks within their Edgecumbe facility boundary. As such, the alignment of associated pipework is only assessed in this PSI up until it reaches the facility boundary, as indicated on Figure 1b.

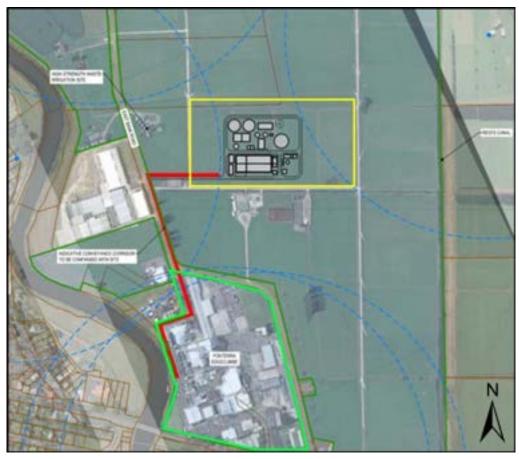
Figure 1b – WWTP overlain on aerial imagery, with associated pipework also assessed as part of this PSI in red. Main boundary of Fonterra Edgecumbe Facility in green. Source: Beca Engineering Project Team ('pre-concept'), May 2022.
